VCS Case Study: Tandem Cold Mill

Stand One Quality Improvement Analysis

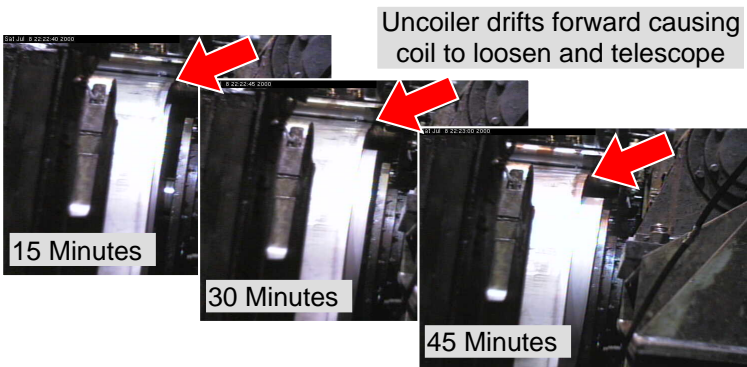
Two to three unexplained Stand One mill wrecks were occurring each month. The VCS video showed that while in delay, the coil at the uncoiler telescoped due to poor tension. When the mill attempted to start up, the arbors were unable to compensate for this side movement.

As coil starts to run, the arbors can't compensate for the telescoped edges - **Coil goes over Stand One Side Guide**

Maintenance personnel reviewed the VCS video and traced the cause to worn brake pads.
