VCS Case Study: Tandem Cold Mill

Stand One Quality Improvement Analysis

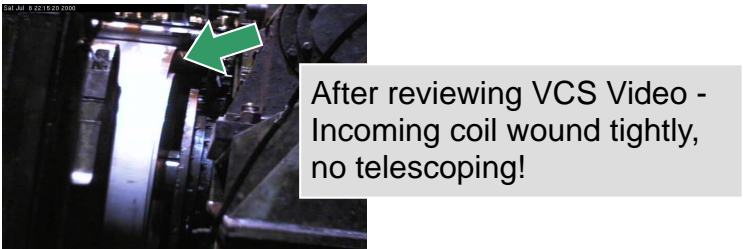
Two to three unexplained Stand One mill wrecks were occurring each month. The VCS video showed that while in delay, the coil at the uncoiler telescoped due to poor tension. When the mill attempted to start up, the arbors were unable to compensate for this side movement.

Maintenance personnel reviewed the VCS video and traced the cause to worn brake pads.
